Reinforced design: MEYLE-HD control arm for Fiat applications

To fit Fiat 500 | Fiat 500C | Ford Ka II

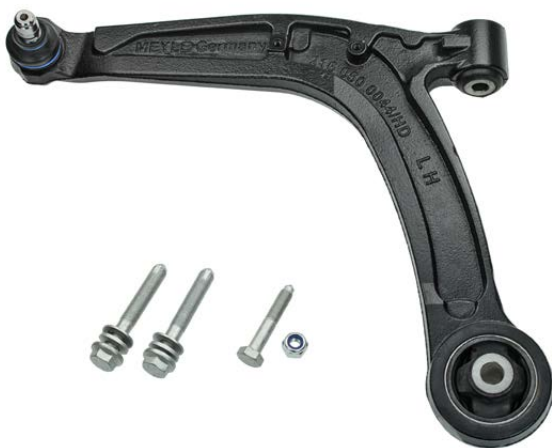
MEYLE-Nr.: 216 050 0044/HD
Short no. MCA0333HD

- Ball joint with long life ball pin designed to offer excellent load-carrying capacities: Larger ball pin diameter delivers increased surface area
- Complete set of mounting parts included
- 4-year guarantee for MEYLE-HD parts
